Saratoga Tree Service

Re 574 Bobwhite, Sunnyvale

A site inspection was performed at the above location to determine the condition of the trees and location on a map of this parcel. I have been informed that the buildings are intended to be demolished.

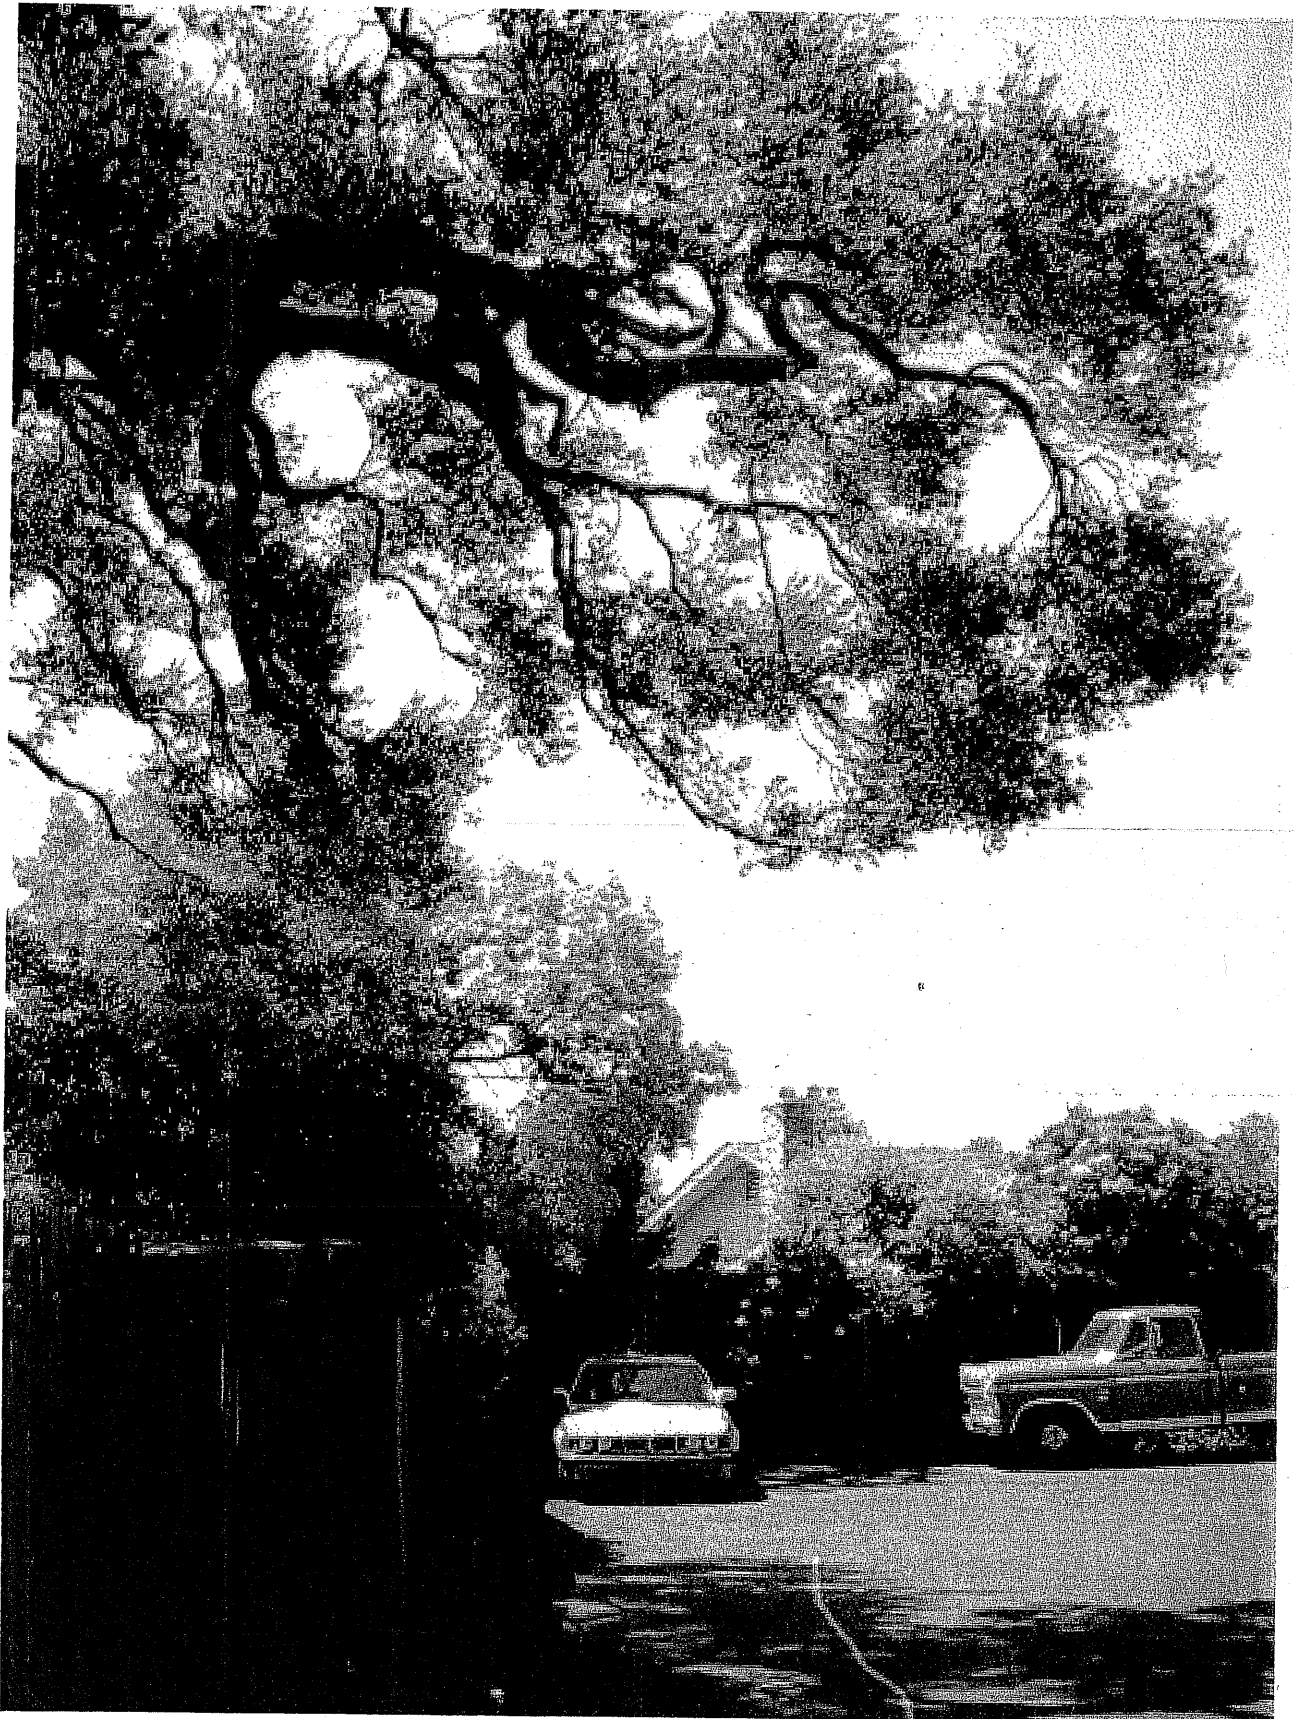
In the area of new foundation, (see photo with paint marks), the tree does have limbs that extend over this area. About 6' of overhang of the drip zone will be impacted by the foundation. This may (or may not) have an adverse effect on the health of the tree. If roots are damaged in this part of the tree root zone then structural stability will not be a factor. Only small roots will be encountered here. (Best not to do any damage if possible). Generally, it is recommended to keep out of the "drip line" whenever possible. A different type of pier and beam foundation would greatly help in minimizing the potential damage to the roots in this area. Because the neighbors house sits directly on a major portion of the root zone, that area was already compromised. Further damage to additional root zone (on such a weakened old tree) is not recommended.

Tree protection measures should be in place at the beginning of the demolition and throughout the project.
